**DEPARTMENT OF TRANSPORTATION**

Contract #: 04-0120F4Cty: SF/ALA Rte: 80 PM: 13.2/13.9File #: 1.28**WELDING INSPECTION REPORT****Resident Engineer:** Casey, William**Address:** 333 Burma Road**City:** Oakland, CA 94607**Report No:** WIR-028839**Date Inspected:** 07-Dec-2012**Project Name:** SAS Superstructure**OSM Arrival Time:** 700**Prime Contractor:** American Bridge/Fluor Enterprises, a JV**OSM Departure Time:** 1730**Contractor:** American Bridge/Fluor Enterprises, a JV**Location:** Job Site**CWI Name:** See below.**CWI Present:** Yes No**Inspected CWI report:** Yes No N/A**Rod Oven in Use:** Yes No N/A**Electrode to specification:** Yes No N/A**Weld Procedures Followed:** Yes No N/A**Qualified Welders:** Yes No N/A**Verified Joint Fit-up:** Yes No N/A**Approved Drawings:** Yes No N/A**Approved WPS:** Yes No N/A**Delayed / Cancelled:** Yes No N/A**Bridge No:** 34-0006**Component:** OBG**Summary of Items Observed:**

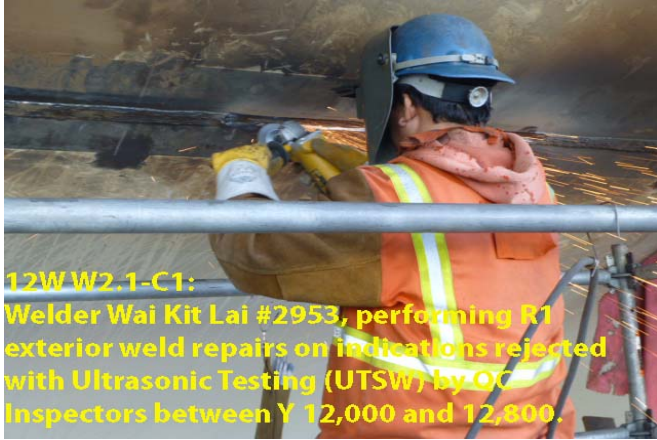
Welder was observed performing R1 exterior weld repairs on weld 12W W2.1-C1 indications rejected with Ultrasonic Testing (UTSW) by QC Inspectors between Y 12,000 and 12,800. Welder was observed utilizing Welding Procedure Specification (WPS) ABF-WPS-D15-1004 Repair for Shielded Metal Arc Welding (SMAW) as per "Request for Weld Repair" or (RWR) 201211-005. Welding parameters as verified by QC Inspector William Sherwood appear to be in compliance with the WPS noted above.

**12W W2.1-C1:**  
Welder Wai Kit Lai #2953, performing R1 exterior weld repairs on indications rejected with Ultrasonic Testing (UTSW) by QC Inspectors between Y 12,000 and 12,800.

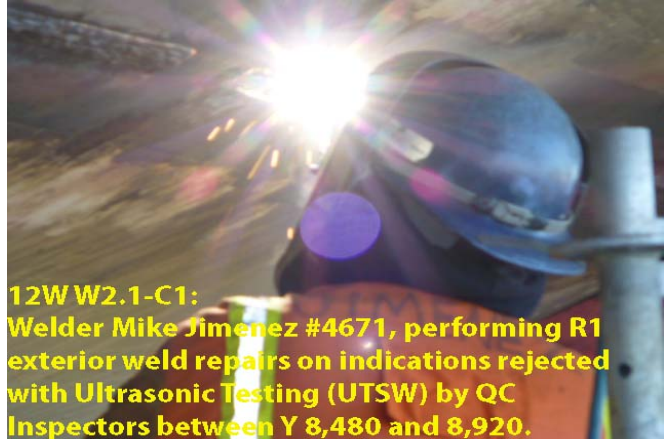
Welder was observed performing R1 interior weld repairs on weld 12W W2.1-C1 indications rejected with Ultrasonic Testing (UTSW) by QC Inspectors between Y 8,480 and 8,920. Welder was observed utilizing Welding Procedure Specification (WPS) ABF-WPS-D15-100 Repair for Shielded Metal Arc Welding (SMAW) as per "Request for Weld Repair" or (RWR) 201211-005. Welding parameters as verified by QC Inspector William Sherwood appear to be in compliance with the WPS noted above.

**12W W2.1-C1:**  
Welder Mike Jimenez #4671, performing R1 exterior weld repairs on indications rejected with Ultrasonic Testing (UTSW) by QC Inspectors between Y 8,480 and 8,920.
